## Tyseley Carriage Sidings

## Operations at Tyseley Carriage Sidings

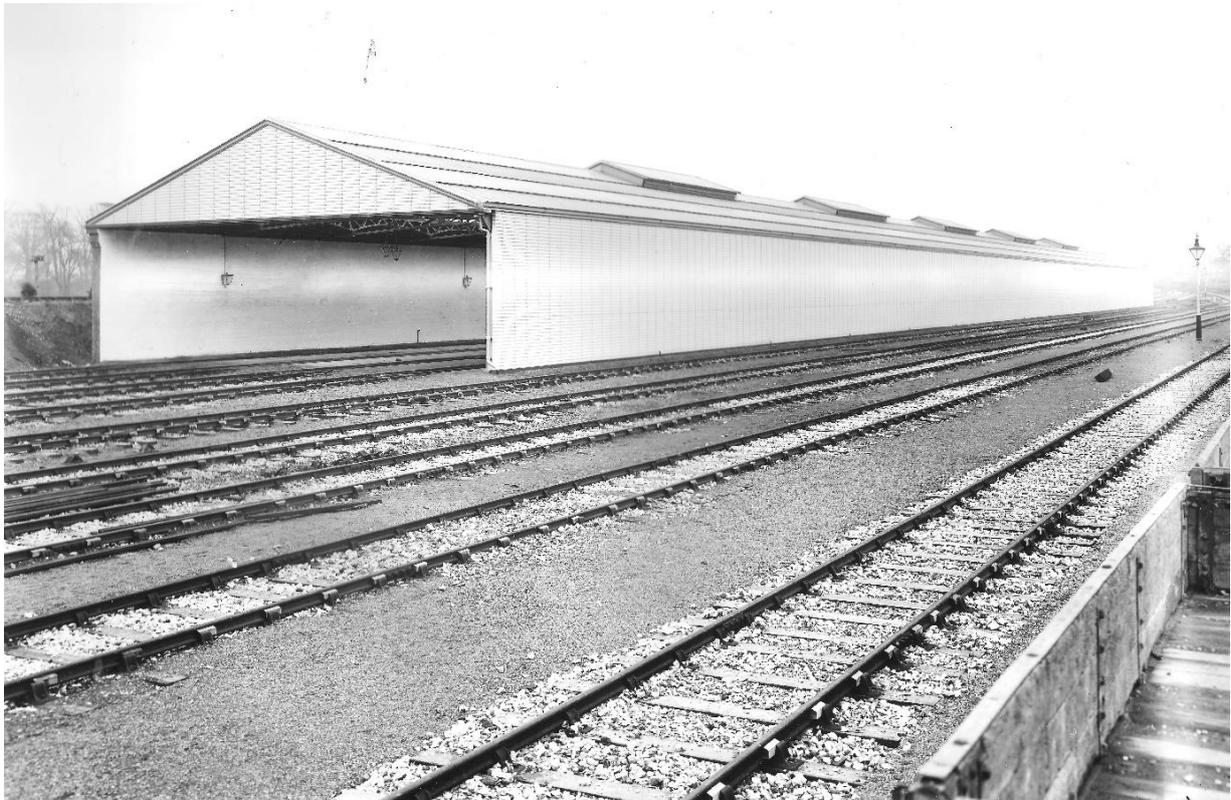
***New Carriage Shed at Tyseley*** – The large new carriage shed adjoining Tyseley station has a length of 600 feet and a height to eaves of roof of 17 feet 6 inches. Its present width is 59 feet, four lines being accommodated. Special provision has been made in the building to admit of its being enlarged when required in the future. With this in view, while a brick wall is built on the side facing the main line, the opposite side, where the extension will be effected, is constructed with a steel frame closed in with the 'Universal Sheeting' manufactured by Messrs Samuel Taylor & Co of Birmingham. This material, in addition to giving a pleasant appearance (an important point with so large a structure), has the advantage over corrugated iron that it may be readily taken down for use elsewhere without injury. The sheeting is used in the roof, which is partially glazed, and at the gable ends also.

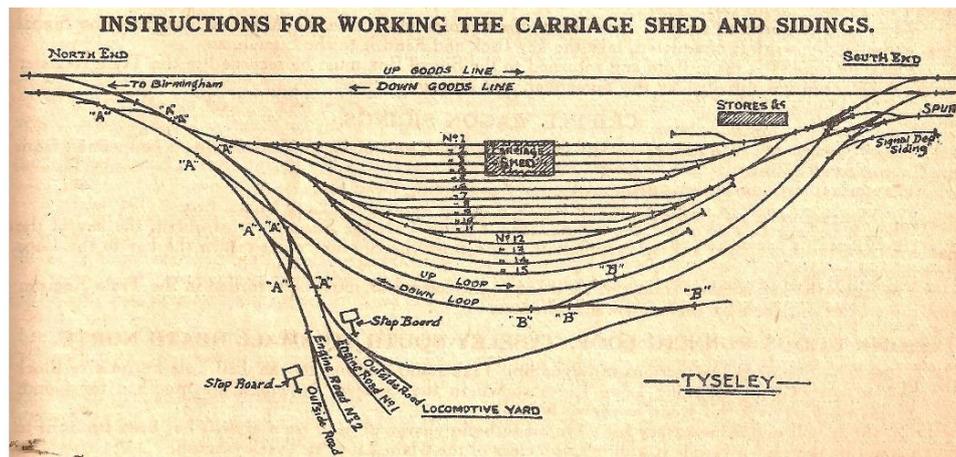
This extract from Great Western Railway Appendix to the Service Timetable for Birmingham Division (Sections No.13 & No.15) is dated March 1929. The plan differs from that in the March 1921 appendix (above) as it shows the three extra dead end sidings (numbered 13, 14 & 15), which were added in 1924.

The short siding adjacent to the single storey building (labelled STORES &c on the plan) is believed to be where travelling oil-gas tank wagons (telegraphic code: CORDON) were placed. A network of buried pipes allowed the oil-gas to be distributed

2. The connections with the Goods Lines at the South end of the Yard are controlled from Tyseley South Signal Box, and the connections (marked "A" on sketch) between the Carriage Sidings and the Locomotive Yard at the North end and the fixed Signals applicable to them are controlled from Tyseley Loco Box.

3. The Sidings are numbered from 1 to 15 as shewn on the diagram, and no Train or Engine must be turned into the Carriage Sidings from the South end without permission from the Shunter on duty, who will be responsible for seeing that everything is clear, and that nothing is allowed to foul the incoming Engine or Train.

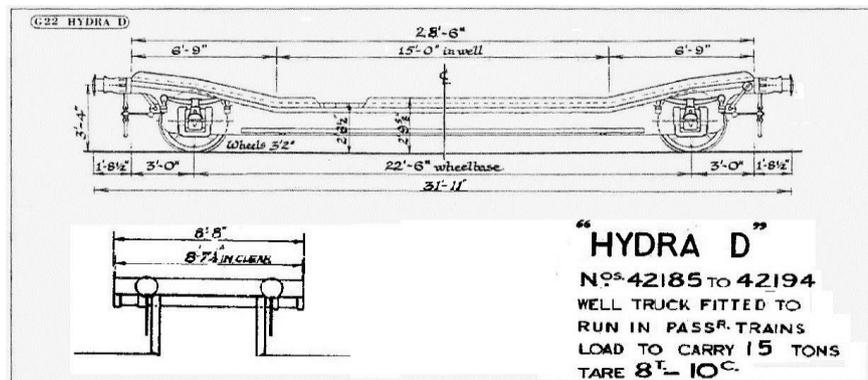
A well wagons rated to carry a load of 15ton (No.42194) is in the Tyseley collection. This particular wagon was built at Swindon Works in 1917 to diagram G22. The Great Western Railway diagram drawing of this wagon is attached:

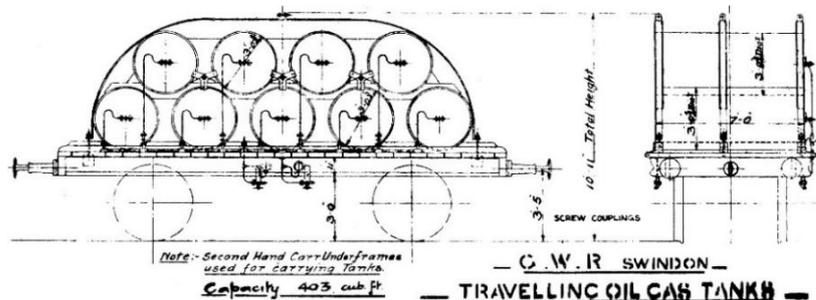
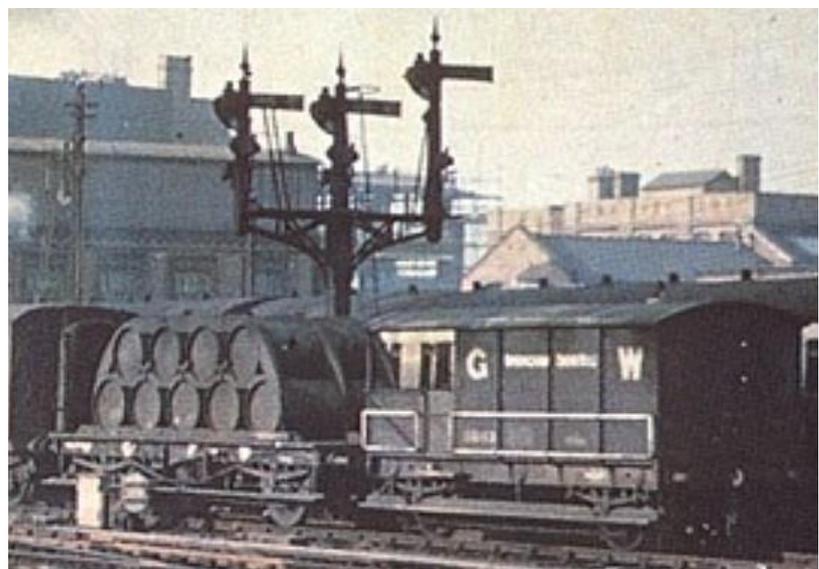
*Official drawing and photograph of a Great Western Railway travelling oil-gas tank wagon (telegraphic code CORDON) to diagram DD4. The photograph was taken on 20<sup>th</sup> February 1939 at the Northwood carriage sidings (located north end of Snow Hill Station). Between March 1903 and January 1933, forty of these wagons were built on the wooden underframes of withdrawn four-wheeled carriages. The nine transverse gas receiving tanks were secured in place with iron straps. These tanks were seven foot long with a three foot diameter and held about 45 cubic feet of oil-gas each. The gas was compressed to 150 psi. Most of these wagon's underframes were renewed in the 1920's and lever brakes fitted.*

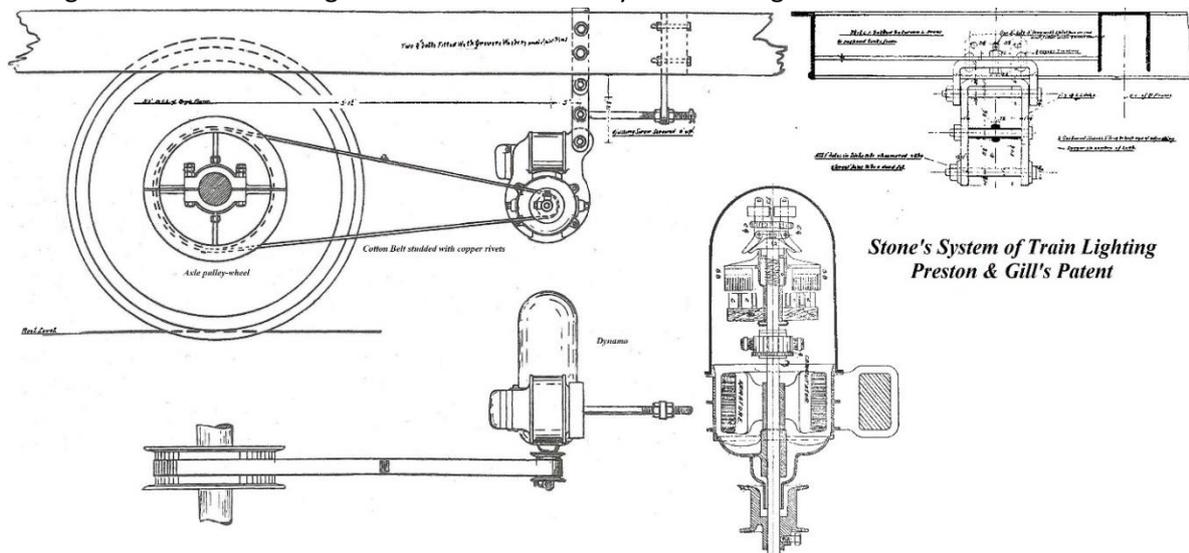
In 1890 the Great Western Railway installed its first electric lighting in three Royal Saloons. This was the 'Stone's double battery system'. A dynamo suspended beneath the carriage underframe on a hinged bracket had a belt driven from a pulley-wheel fixed to one of the rotating carriage axles. This meant that the dynamo's output was dependent upon the speed of the train with the output voltage would fluctuating during the journey. The difference between the diameters of the axle pulley-wheel and dynamo shaft meant that the dynamo rotated about three times as fast as the axle and at high speeds the resulting output voltage of the dynamo could over-charge and damage the accumulators. This was resolved by using a cotton drive belt studded with copper rivets and adjusting the tension on the belt such that it slipped on the pulley-wheel at speeds over 12mph. At low speeds the opposite problem occurred, as the dynamo output voltage would be insufficient to power the electric lights in the carriage. This was resolved by powering the carriage lights from one battery of accumulators, while a second battery of accumulators was connected to the dynamo for recharging when the train was moving. Having two sets of batteries. As these early dynamos were non-reversible having two batteries of accumulators arranged with opposite polarities meant one battery could be charged when the train travelled in one direction and the other battery charged on the return journey. An automatic switch was provided to reverse the connections when the train changed direction. The diagram below shows the dynamo arrangement:

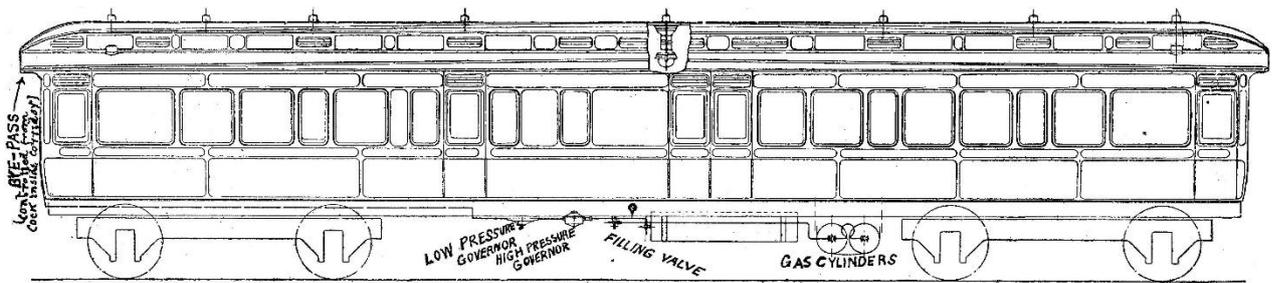
*Drawing showing the position of the principle Gas Lighting components in Director's Saloon No.249 (diagram G3). This coach was ordered on 24<sup>th</sup> August 1894 (Lot 745) and completed at Swindon Works on 22nd October 1894 with conventional oil-gas lighting. It was modified by Mr Riley for the experiments with inverted incandescent gas mantles. By 1910 this saloon was stationed at Old Oak Common and renumbered No.9045.*

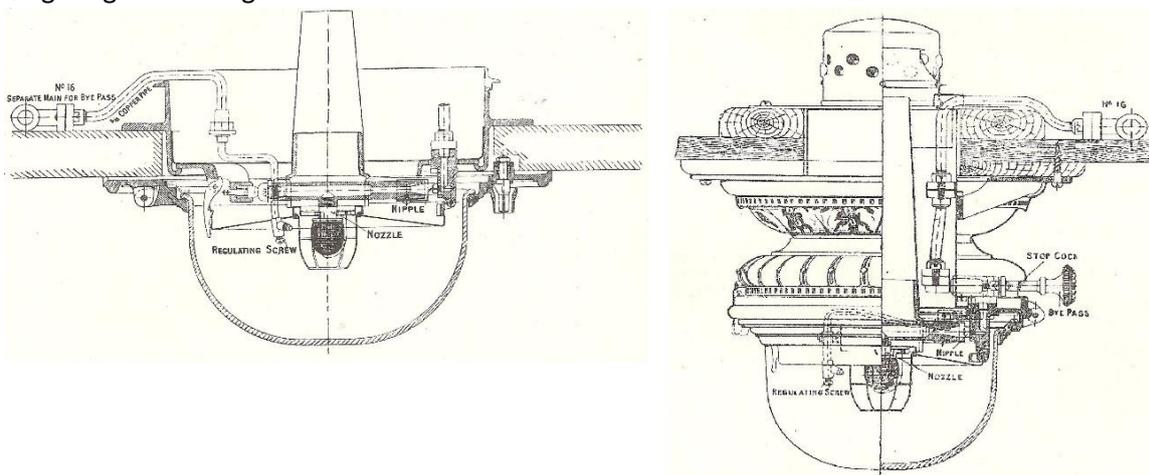
*The drawings show; (1) a conventional Pintsch oil-gas light fitting adapted to allow an incandescent gas mantle to be fitted and (2) a new Pintsch oil-gas light with an incandescent mantle and a separate pilot light supply.*

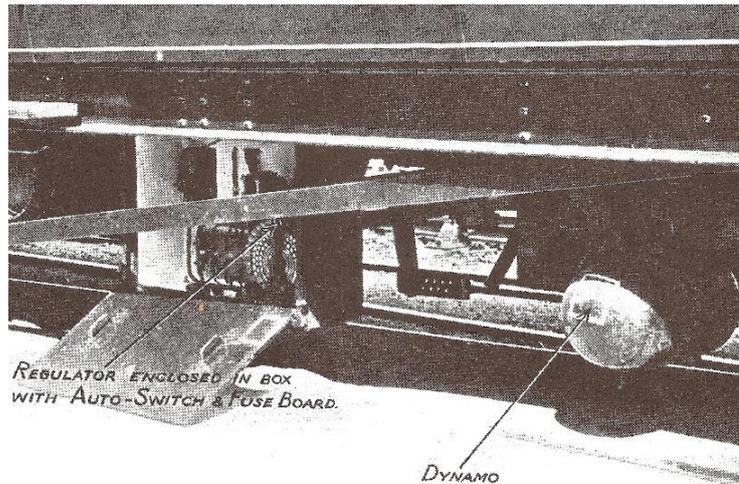
The photograph shows a typical installation under a Great Western Railway coach in 1924.
