Signalman's ARP Shelter (Tin Coffin)

This Air Raid Precaution (ARP) Signalman's Air-raid shelter was discovered at Tyseley in the Summer of 2022. It is believed to have come to Tyseley with the Great Western Railway Holesmouth Signal Box in 1985. This Signal Box had worked the junction into the Avonmouth (Prince Edward) Docks outside Bristol. These docks were a prime target for the German air-force during WW2 as they handled imported oil and petrol products which were needed for the war effort. Holesmouth Signal Box was rebuilt on the same site after the previous Signal Box was destroyed during an air-raid in April 1941. Rebuilding took a month with only the important frame from the original signal box being salvaged.

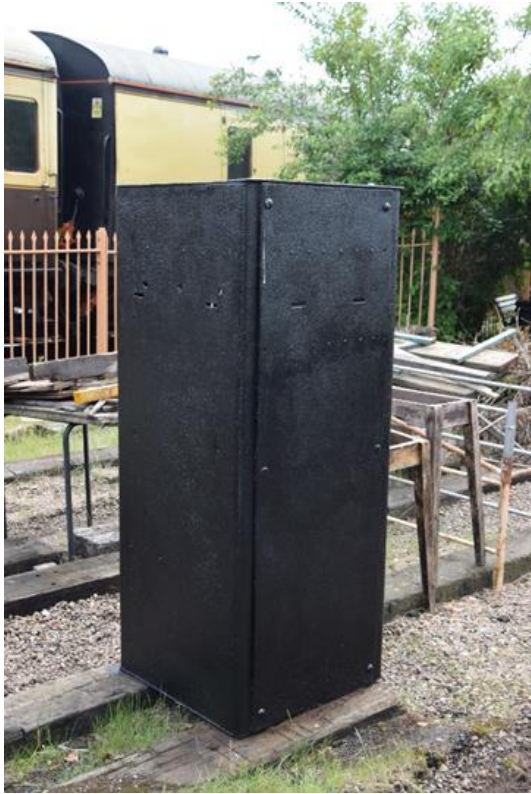
The Signaller's ARP Shelter at Tyseley has been painted by volunteers to help preserve it and a replacement seat will be installed. When first located the shelter's door was missing, but this was found in September and has now been reattached. No serial numbers or other markings have been discovered so far.
