Tyseley Carriage Sidings

Operations at Tyseley Carriage Sidings

Appendix 1 – Development of Carriage Lighting on the Great Western Railway

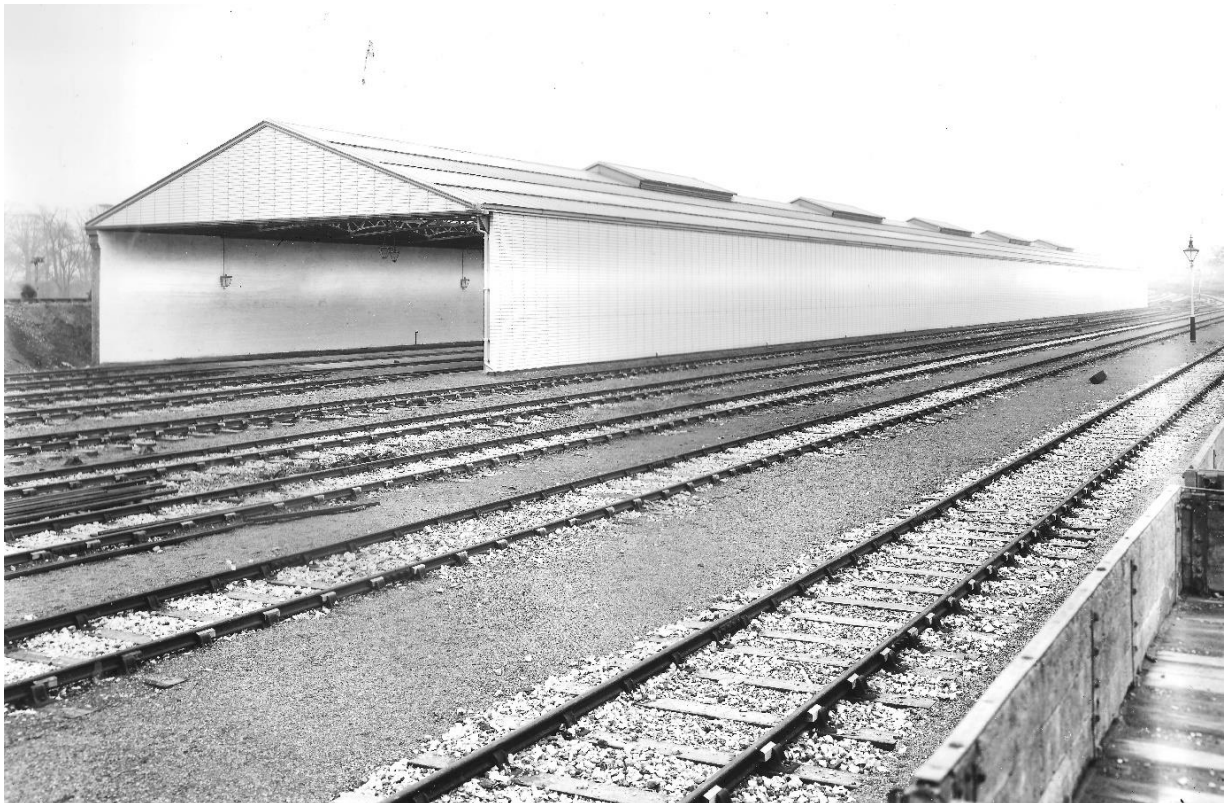
New Carriage Shed at Tyseley – The large new carriage shed adjoining Tyseley station has a length of 600 feet and a height to eaves of roof of 17 feet 6 inches. Its present width is 59 feet, four lines being accommodated. Special provision has been made in the building to admit of its being enlarged when required in the future. With this in view, while a brick wall is built on the side facing the main line, the opposite side, where the extension will be effected, is constructed with a steel frame closed in with the 'Universal Sheeting' manufactured by Messrs Samuel Taylor & Co of Birmingham. This material, in addition to giving a pleasant appearance (an important point with so large a structure), has the advantage over corrugated iron that it may be readily taken down for use elsewhere without injury. The sheeting is used in the roof, which is partially glazed, and at the gable ends also.

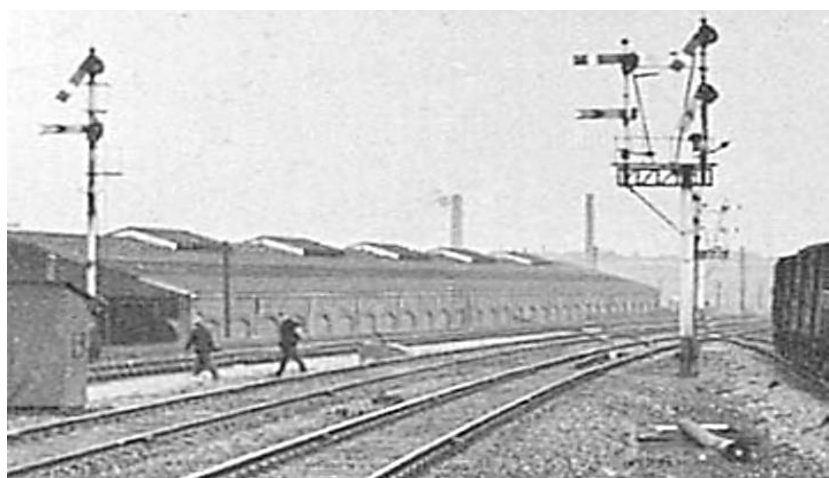
This plan from the Appendix to the Service Timetables for Birmingham Division (Section Nos.12 & 14) is dated March 1921. It shows the original layout with twelve long carriage sidings sandwiched between the Down Goods line and the new locomotive roundhouses. The Carriage Shed covered the four sidings closest to the Down Goods line. The instructions required siding No.6 to be always kept clear for receiving empty stock trains from Birmingham.

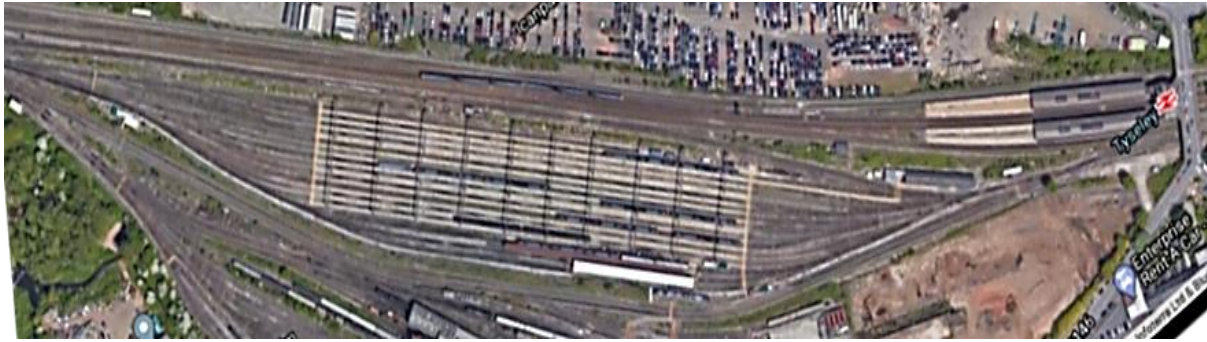
On 4th January 1976, a new connection was laid down at the northern approach and an additional road constructed on the mainline side of the carriage shed. This through siding was on the track-bed of the up and down goods lines which had been taken out of use on 28th January 1968. It was brought in to use on 4th April 1976 and equipped with a drive-through carriage washer. The following year the carriage shed was demolished and the sidings were reconstructed. Twelve parallel through roads were provided with 300 metre covered aprons and overhead lighting gantries to facilitate night-time working. Half of the aprons were provided with refuelling points. The twelve through roads were complimented by a two road maintenance shed, while three other sidings were retained for storage. The layout of the carriage sidings can be seen in this recent aerial image of the site:

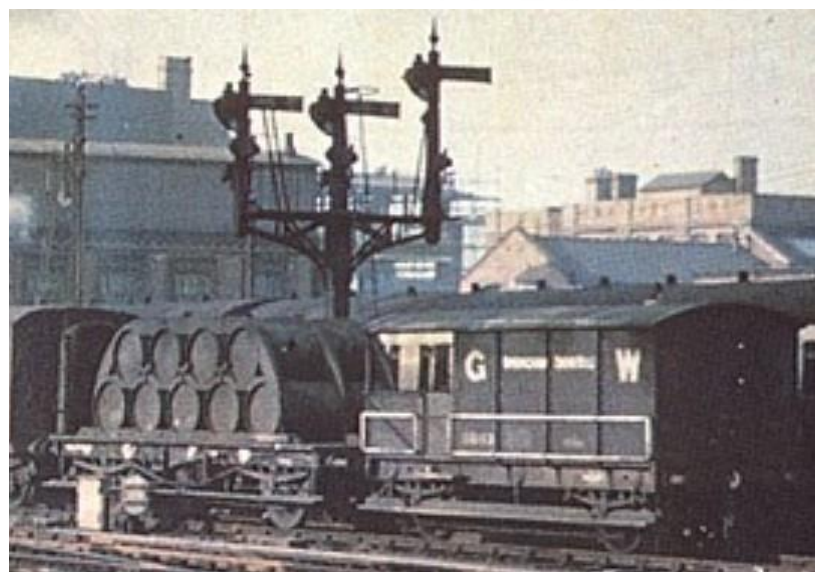
Official drawing and photograph of a Great Western Railway travelling oil-gas tank wagon (telegraphic code CORDON) to diagram DD4. The photograph was taken on 20th February 1939 at the Northwood carriage sidings (located north end of Snow Hill Station). Between March 1903 and January 1933, forty of these wagons were built on the wooden underframes of withdrawn four-wheeled carriages. The nine transverse gas receiving tanks were secured in place with iron straps. These tanks were seven foot long with a three foot diameter and held about 45 cubic feet of oil-gas each. The gas was compressed to 150 psi. Most of these wagon's underframes were renewed in the 1920's and lever brakes fitted.
